page 1 of 7 Test No.: 4404

In test 4404 we will investigate the lifespan of CF270.UL.D in an E6.52.075.125.0 echain.

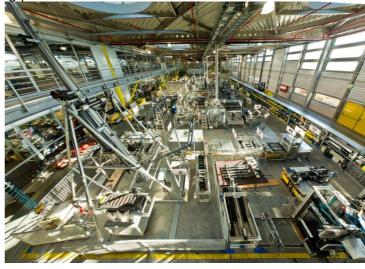
This test is built up on the "Zollern". The following pictures show the test structure:

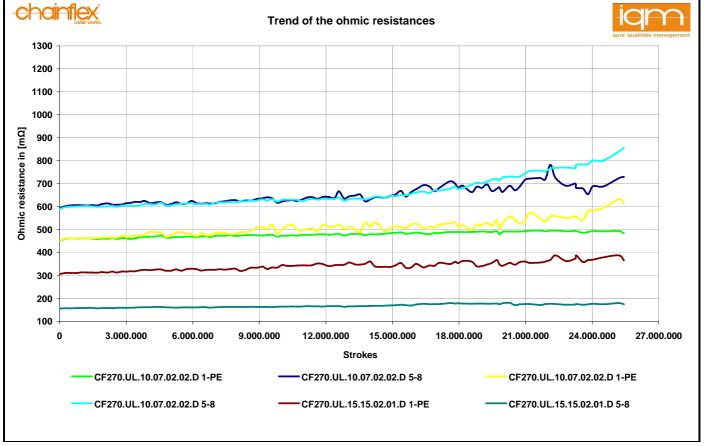
The following diagrams show the trend of the ohmic resistances during the test:

To detect broken conductor or shielding wires we will measure the ohmic resistance of these cable elements. The cores of the samples are connected in series and one core is connected with the shielding to measure the ohmic resistances.

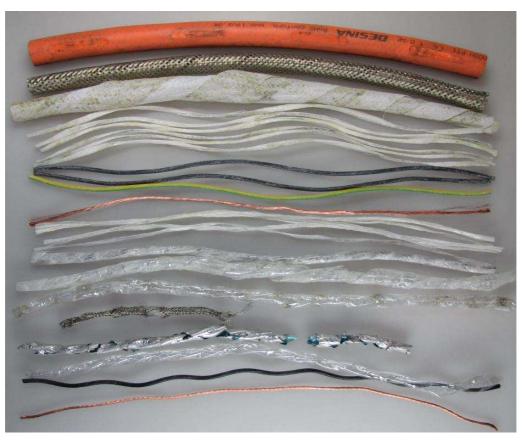
Cable no.1.1

The condition of the cable no.1.1 & 1.2 (CF27.15.07.02.02.D) after 26.528.188 strokes

Cable no.	1.1	1.2	
Strokes	26.528.188		
Condition outer jacket	o.k.	o.k.	
Condition overall shielding	ruptured	o.k.	
Condition fleece tape	o.k. (discoloured)	o.k. (discoloured)	
Condition core insulation	o.k.	o.k.	
Condition conductor	o.k.	Broken single wires	
Condition centre element	o.k.	o.k.	
Element cores			
Condition core insulation	o.k.	o.k.	
Condition conductor	o.k.	Broken single wires

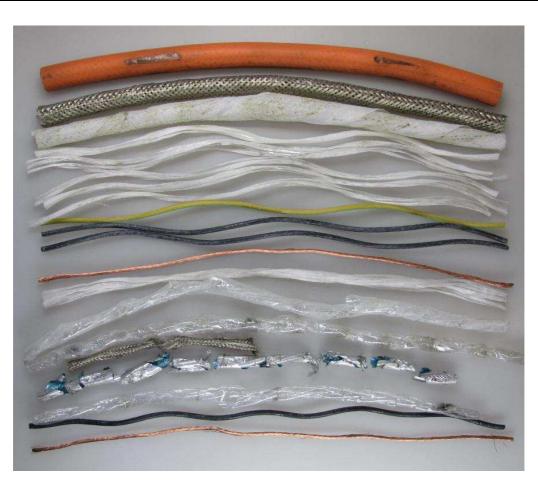
The condition of the cable no.2.1 (CF27.15.10.02.01.D) after 26.528.188 double strokes

Strokes	26.528.188	
Condition outer jacket	o.k.	
Condition overall shielding	ruptured	
Condition fleece tape	o.k. (discoloured)	
Condition core insulation	o.k.	
Condition conductor	o.k.	
Condition centre element	o.k.	
Element cores		
Condition core insulation	o.k.	
Condition conductor	o.k.
