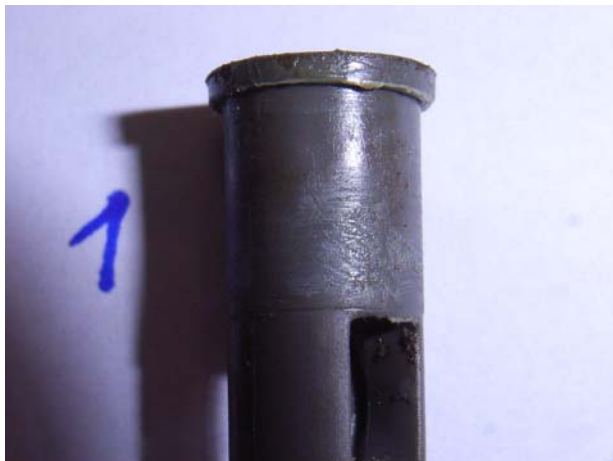
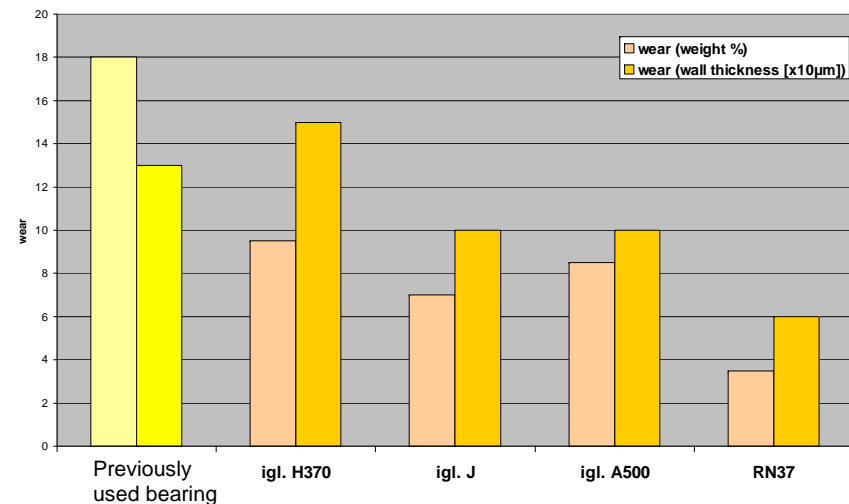
Previously used bearing

- Run also in tests at CUSTOMER
- Broken ends of the bearing where they were not press-fitted (probably chem. attack)
- Most wear of all tested bushings

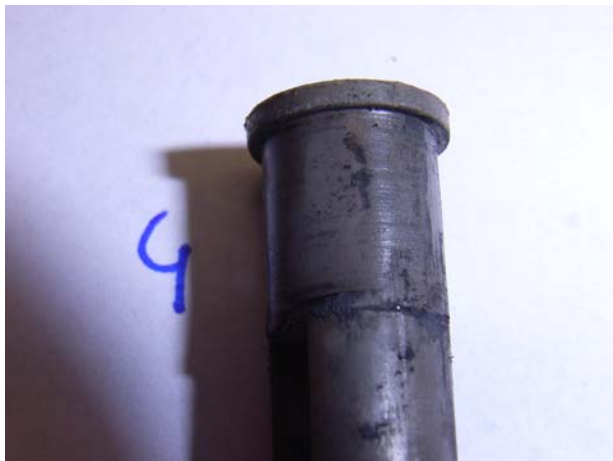
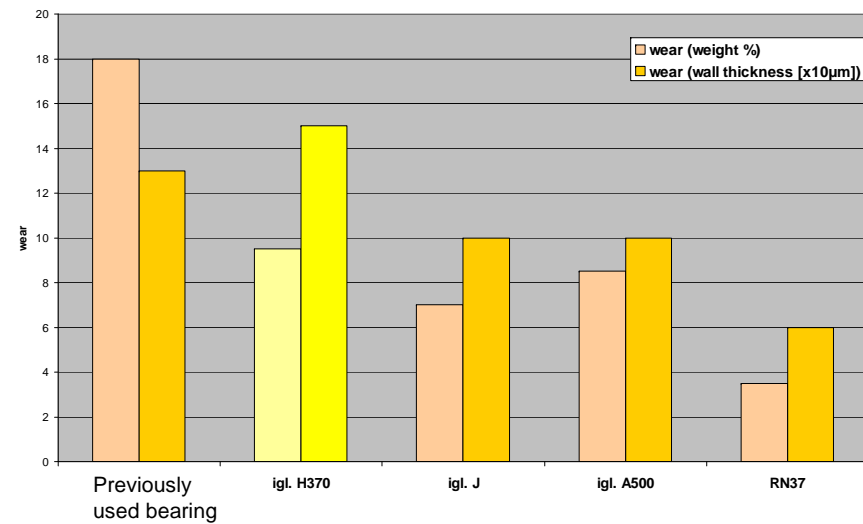
iglidur[®] H370

- Run also in lot of application, but against steel shafts
- More wear at the drive gears than all other bearings

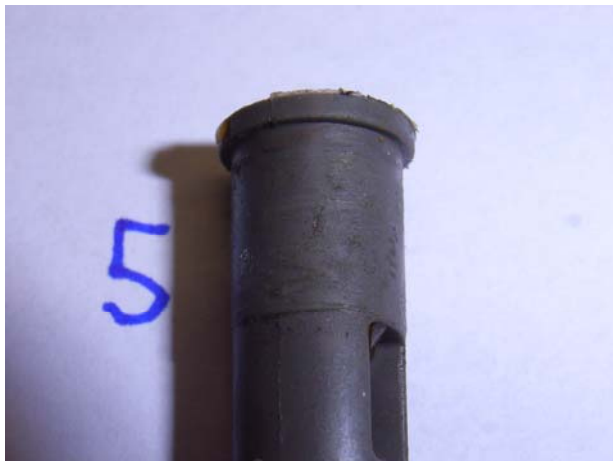
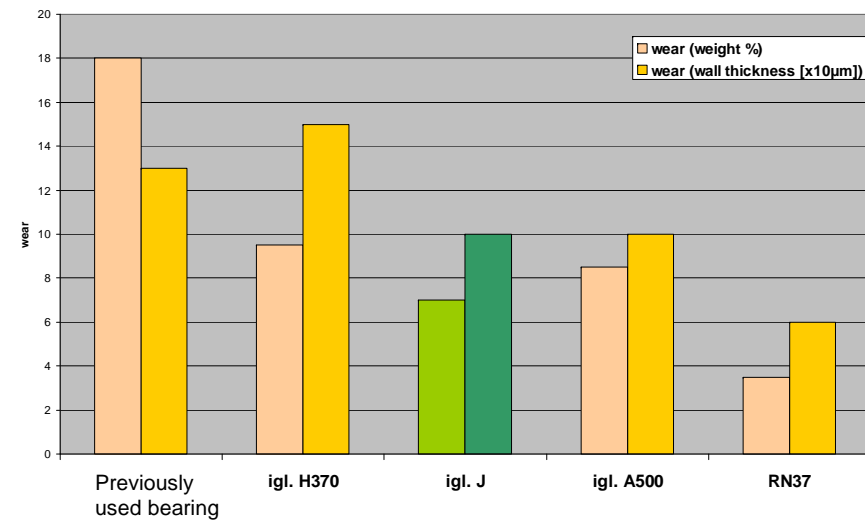
iglidur[®] J

- Best price-performance-ratio recommendation

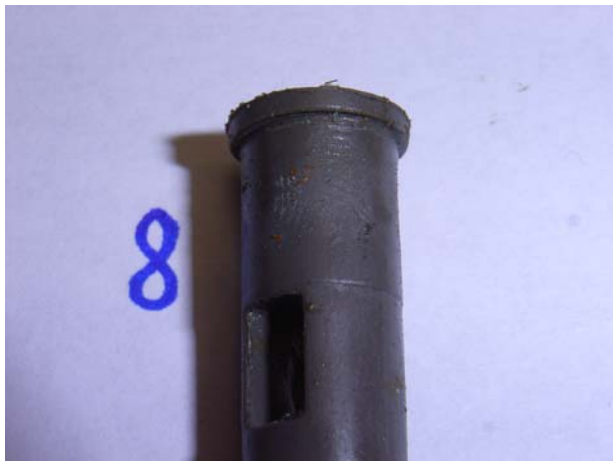
iglidur® A500

- Highest chemical resistance

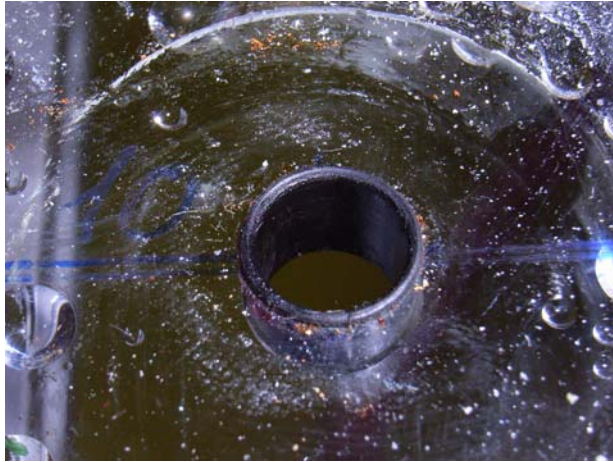
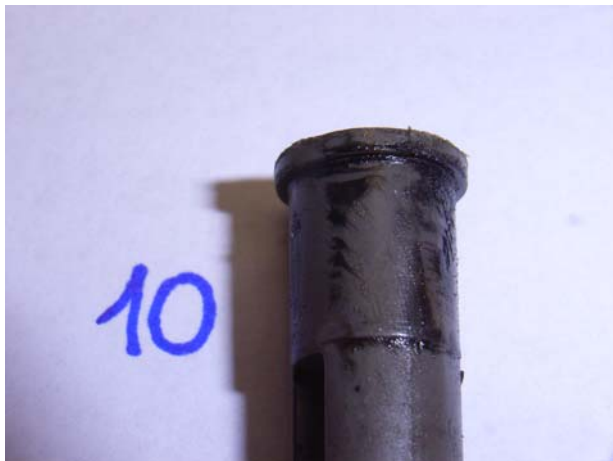
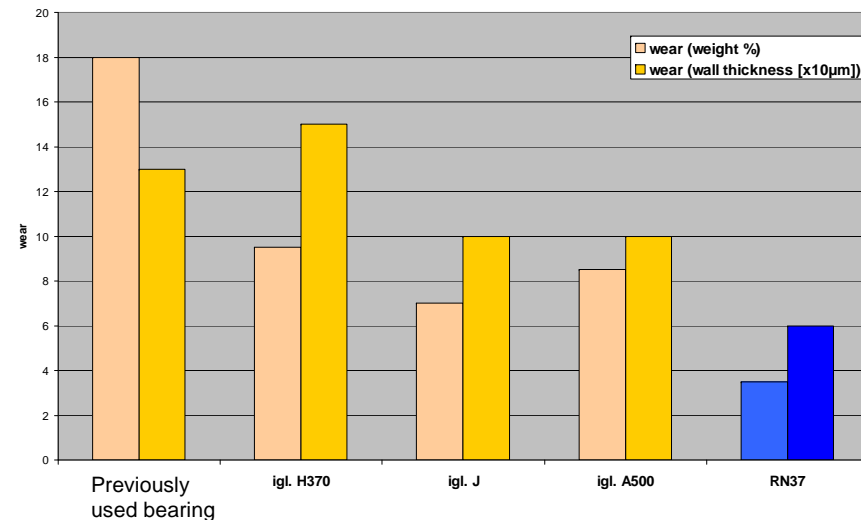
iglidur® RN37

- Used as bushing for stainless steel in water pumps
- Shaft looks a little different, but no measurable wear
