Test-Report chainflex®

Test No.: **3351**

Test Intention:
In test 3351 we want to investigate the lifespan of a CFROBOT.036 in torsion application.

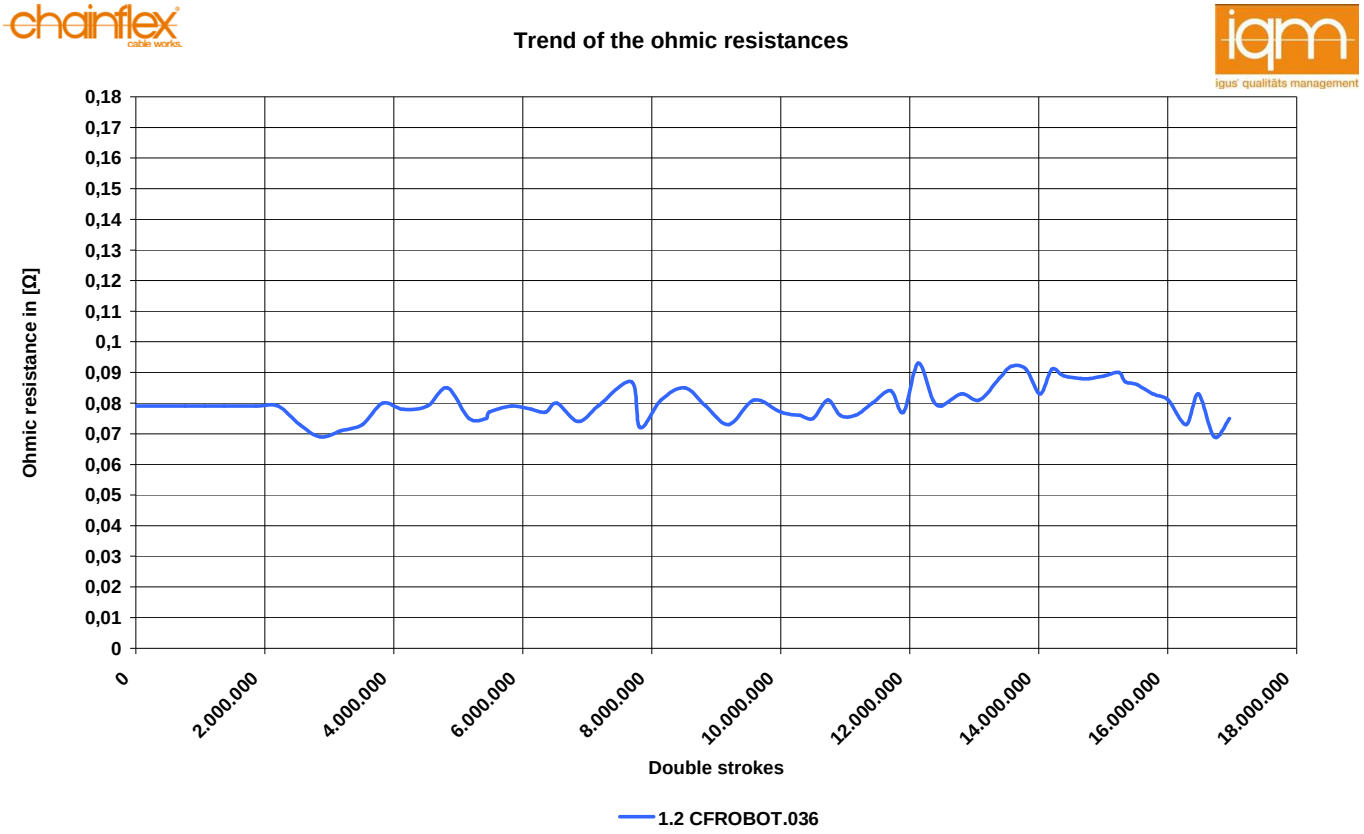
At the 10.05.2012 we demounted cable no. 1.1 after 17.099.049 cycles to finalize the test

The following diagram shows the trend of the ohmic resistances during the test:

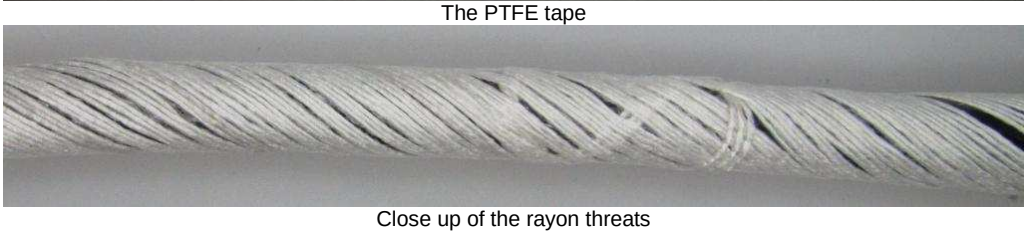
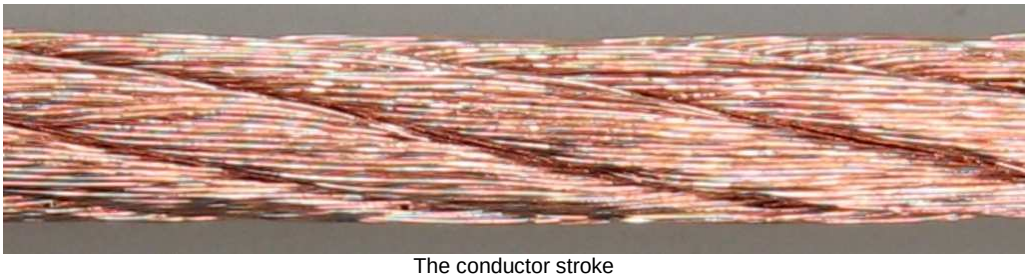
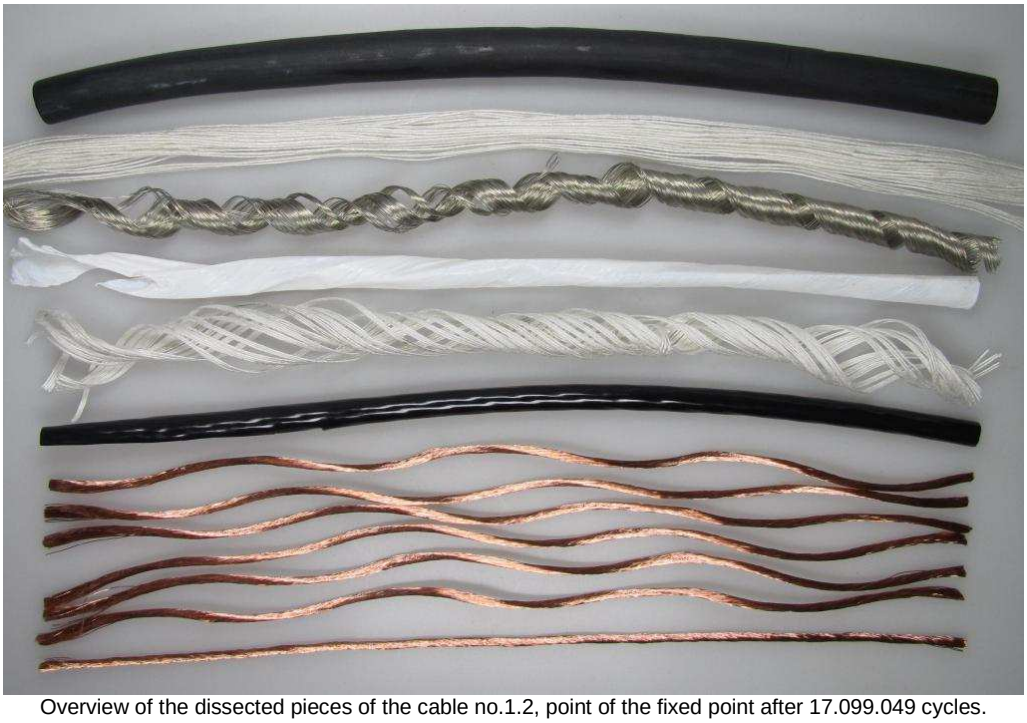
Cable no.1.1 CFROBOT.036 (fixed point)

The condition of the cable no.1.1 (CFROBOT.036) after 17.099.049 cycles

Overview of the dissected pieces of the cable no.1.2, point of the fixed point after 17.099.049 cycles.

Cycles	17.099.049
Condition outer jacket	Ok
Rayon thread:	Ok
Condition overall shielding	Ok
PTFE foil:	Ok
Inner rayon thread:	Ok
Condition core insulation	Ok
Condition conductor	Ok

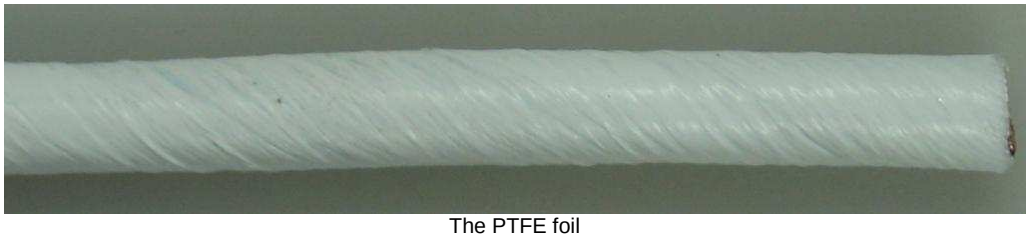
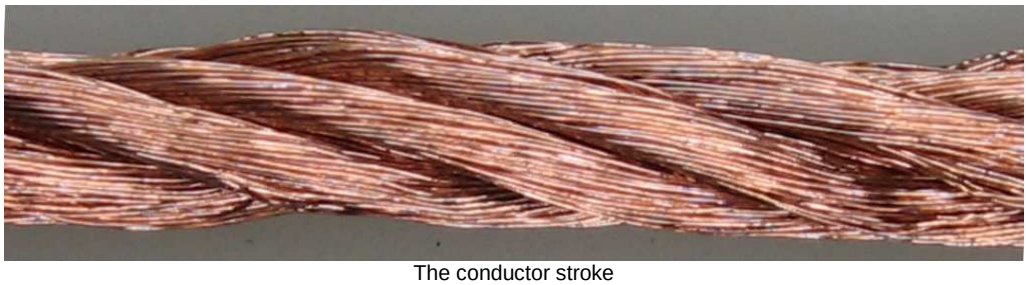
Cable no.1.1 CFROBOT.036 (middle point)

Overview of the dissected pieces of the cable no.1.2, point of the middle point after 17.099.049 cycles.

Cycles	17.099.049
Condition outer jacket	Ok
Rayon thread:	Ok
Condition overall shielding	Ok
PTFE foil:	Ok
Inner rayon thread:	Ok
Condition core insulation	Ok
Condition conductor	Ok
